Inexperience or Ignorance is not a bliss Onboard Ship

Capt. Mani Rajakumar Faculty, Nautical Science, AMET University

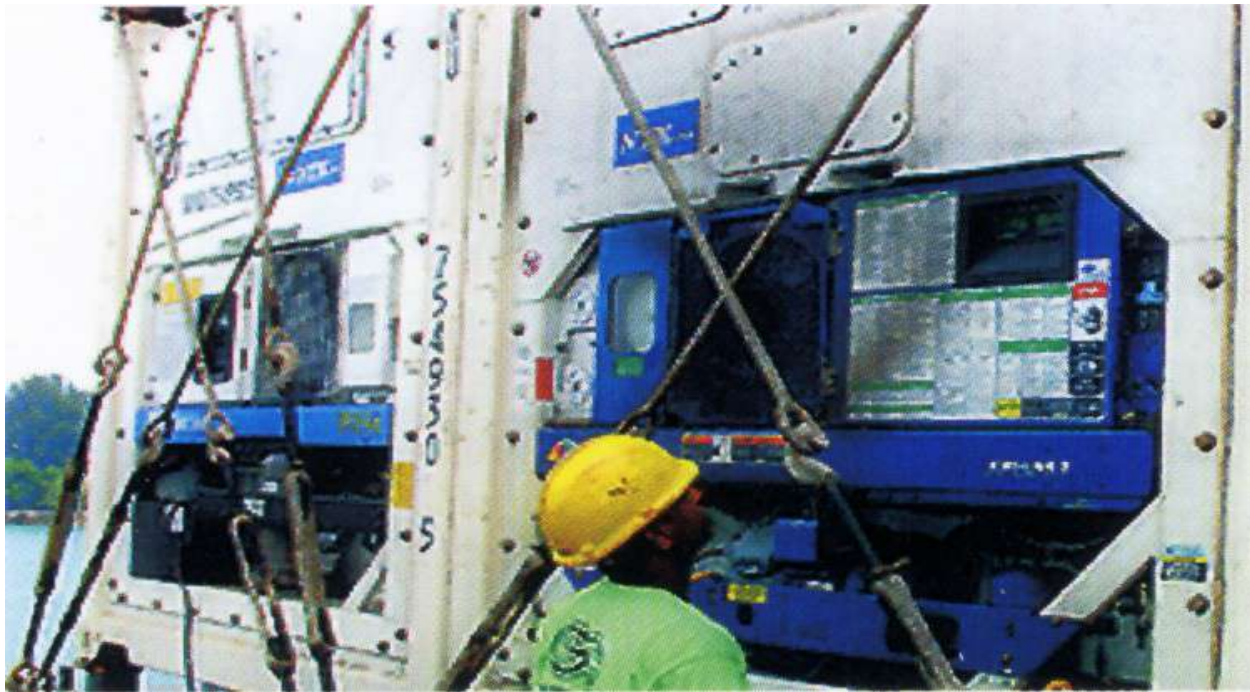
440V switchboard used by Ship's crew for plugging / unplugging Reefers

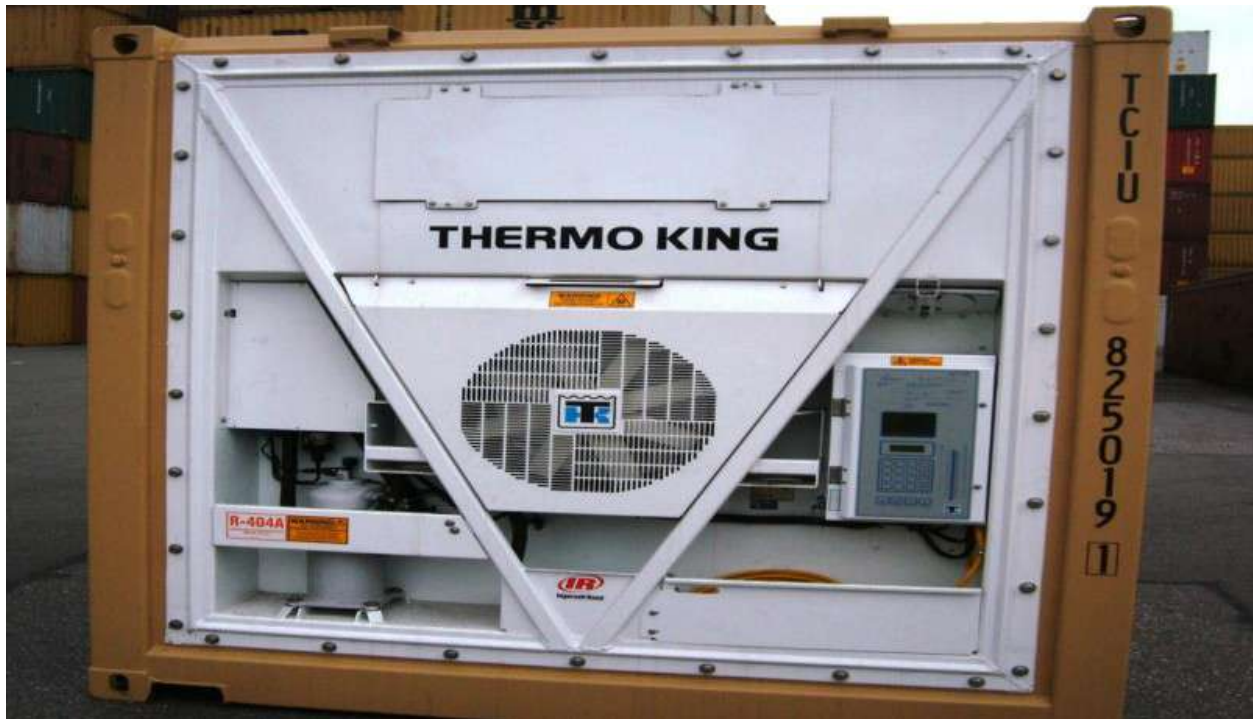
Panel on the reefer unit where local power switch is located

These containers were found plugged in but their machinery was not running. From the log he noted that the units were idle for the past 12 hours. All the units were close to the lashing bridge on Bay 54 and were found turned off from the local power switch in the unit. This act puzzled the ship's crew as they usually turn them off by unplugging the power cord from the 440V switchboard. Upon investigation the duty A/B
