Inexperience or Ignorance is not a bliss Onboard Ship

Capt. Mani Rajakumar Faculty, Nautical Science, AMET University

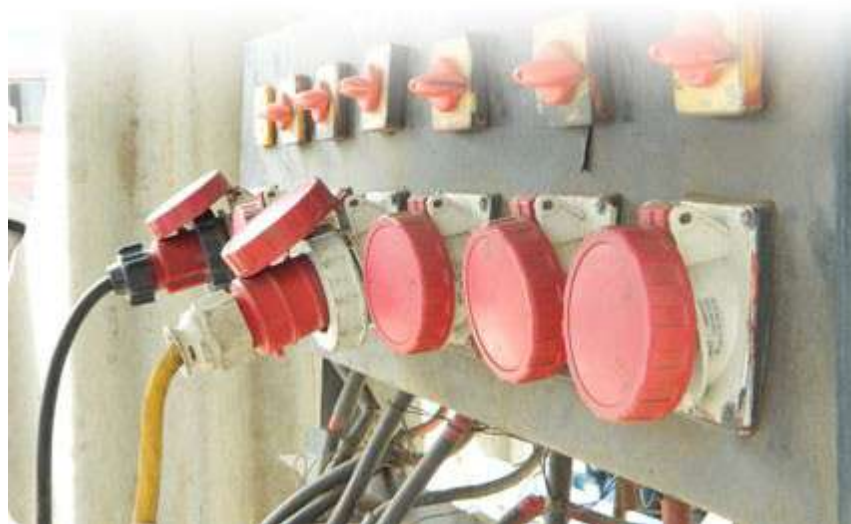
440V switchboard used by Ship's crew for plugging / unplugging Reefers

These containers were found plugged in but their machinery was not running. From the log he noted that the units were idle for the past 12 hours. All the units were close to the lashing bridge on Bay 54 and were found turned off from the local power switch in the unit. This act puzzled the ship's crew as they usually turn them off by unplugging the power cord from the 440V switchboard. Upon investigation the duty A/B
